ANNUAL REPORT

ARCHÆOLOGICAL DEPARTMENT

SOUTHERN CIRCLE, MADRAS

1914-1915

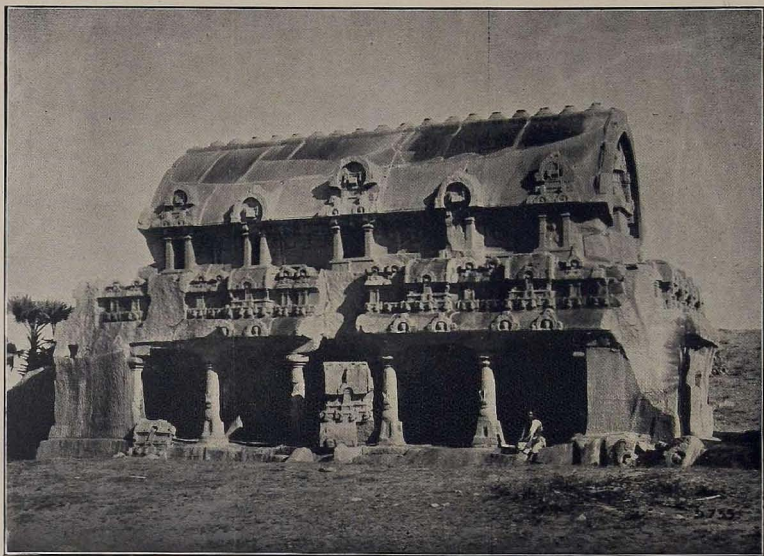
PLATE I. (a).

Bhima's ratha at Mahābalipuram. (Before repairs.)

12. I mentioned in my last report that repairs were in progress to that famous group of monuments at Mahābalipuram generally known as the Seven Pagodas, and it is pleasant to be able to relate here that satisfactory progress has been made with the work in question. The famous and interesting monument known as Bhima's Ratha is now in good order. Repairs to this monument have been in progress for some years, but they have only just been completed. Plate I (a) shows the condition of the monument before repairs. It will be noticed that one huge block had fallen out of the facade of the building above the two central pillars, thus ruining the appearance of the cornice at this point, and that large portions of the two ends or angles of the building on this side were missing. These have all been skilfully refixed by the Public Works Department some time ago, and this year we have introduced new cut stone pillars and beams immediately behind the two central pillars to give additional support to the roof of the verandah at this point where it is very seriously cracked. The open cracks in the outer surface of the building have been closed with cement. Plate I (b) shows the building after repairs. A detailed description of this monument will be found in Part II of this report.

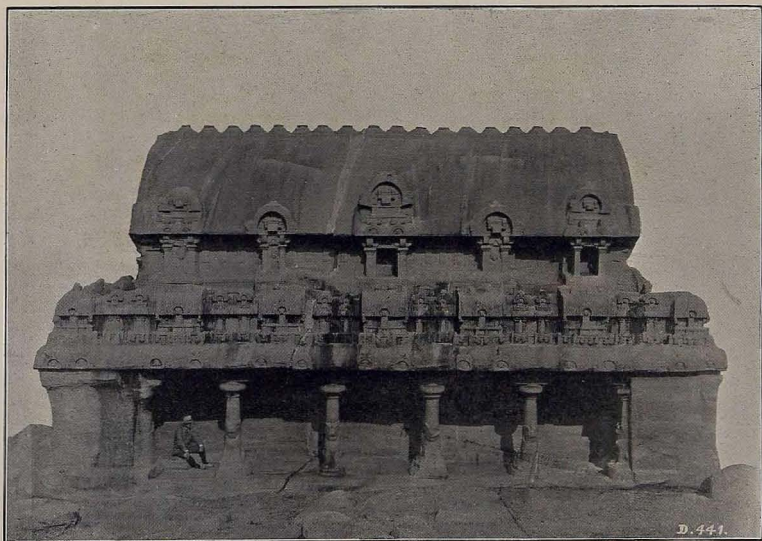
PLATE I. (b).

Bhima's ratha at Mahābalipuram. (After repairs.)

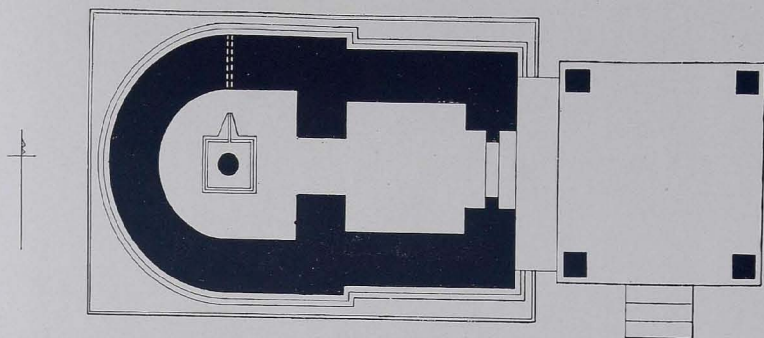
PLATE II. (a).

13. Plate II (a) shows the condition of the outside of the interesting little apsidal-ended Siva temple at Oragadam in the Chingleput district before the repairs undertaken last year were put in hand. The old plaster work had decayed and fallen, leaving the brickwork below exposed, this was fast crumbling away and the roof was in a very leaky condition in consequence. The holes in the brickwork were repaired, and the whole roof neatly replastered, care being taken to faithfully reproduce all stucco figures and ornaments in their original forms. Cracks and open joints in the stone work were pointed in order to keep out water and to prevent the growth of vegetation between the joints of the masonry. The flat roof over the hall and porch in front of the building has been repaired and made watertight, and the inner roof over the shrine chamber (See Plate III) has been renewed with teakwood joists, concrete and plaster. The broken and missing finials crowning the roof have been replaced by new ones. Plate II (b) shows the building as it now appears after the completion of the repairs. A description of this building will be found in Part II of this report.

The Vādāmallisvara temple at Oragadam, Chingleput district. (Before repairs.)
